AFRL-ML-WP-TP-2006-412

**ADVANCED IMAGING OF HIDDEN
DAMAGE UNDER AIRCRAFT
COATINGS (PREPRINT)**

James Blackshire and Adam Cooney

14. ABSTRACT The paper describes the evaluation of several advanced imaging methods for detecting damage hidden under aircraft coating systems. The specific imaging technologies include thermographic imaging, mid-infrared imaging, and terahertz imaging which are all relatively mature and widely known throughout the scientific community.

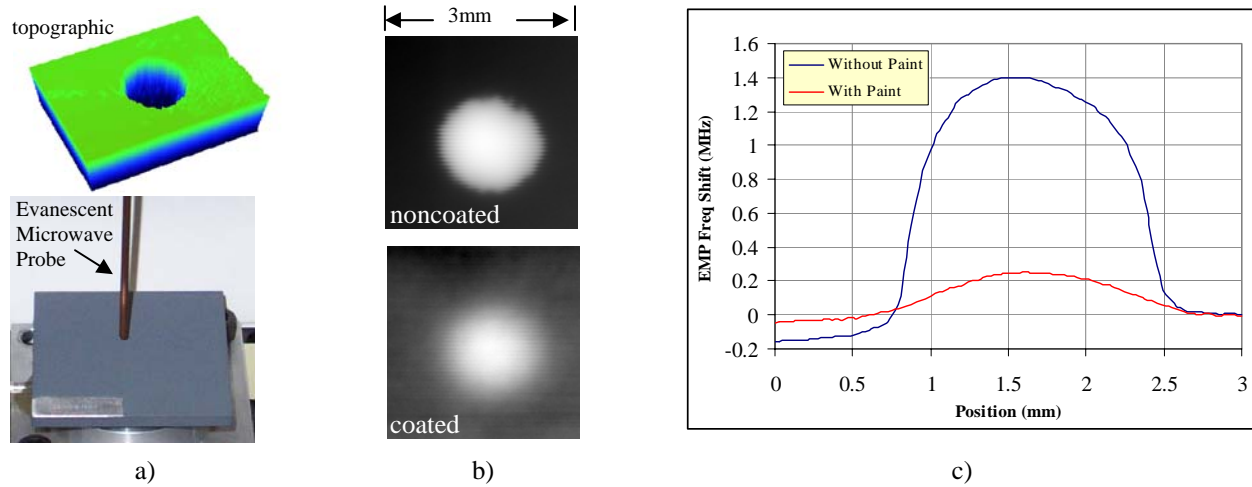
Fig. 7. a) Evanescent microwave probe system measuring of coated corrosion pit sample, b) microwave images taken with and without coating layer present, c) comparison of response signals across corrosion pit location with and without coating present.

The basic technique monitors the resonant interaction of a material substrate with a localized microwave signal in the low gigahertz range, where resonant frequency shifts and power loss measurements are used to characterize the material's conductivity, dielectric response, and topography. By raster-scanning the probe relative to the material's surface, a high resolution image can be generated with spatial resolutions in the 1-100 μ m range. Figure 7a depicts a coated corrosion sample being scanned by the microwave probe along with a topographic plot of the hidden corrosion feature. Figure 7b and 7c provide measurement results for the corrosion pit with and without the coating present. A loss of resolution and reduction in signal level can be seen in the measurement results for the coated sample relative to the noncoated sample.

For raster-scanned measurement systems, resolution levels will be determined primarily by the probe interaction footprint and the step-size of the scan. For imaging methods, resolution will be determined by the various imaging system parameters such as aperture, focusing conditions, and sensing array parameters. In most cases, the resolution limits of the NDE method will be in the 10's of micron range to mm levels. Excellent resolution capabilities, for example, are seen in the immersion ultrasound and thermographic results presented in Figures 5-10 above. Coating type, coating thickness, and geometric complexity again tend to reduce resolution levels as depicted in the microwave measurements depicted in Figure 7.

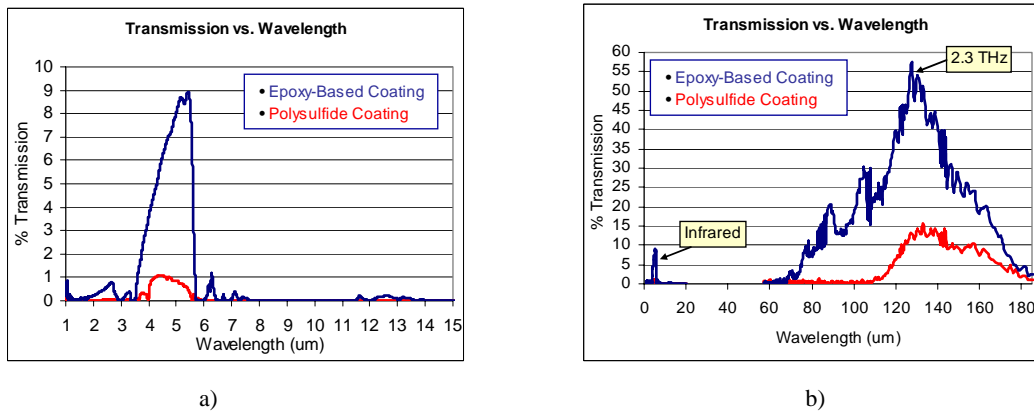
Fig. 8. a) Infrared transmission spectra for epoxy-based and polysulfide coatings, and b) comparison of infrared and terahertz transmission spectra.

The ability to capture a full-field image of a hidden damage under a simple paint layer is very appealing, and passive thermography provides an attractive means for accomplishing this. Current state-of-the-art, focal-plane array infrared camera systems have excellent temperature sensitivities (25mK) and resolution capabilities (30 μ m). Infrared camera manufacturers have also customized the spectral response characteristics of their systems to cover the near-IR to far-IR. An Indigo Merlin MWIR camera was used in this effort to image hidden corrosion features under paint. Its spectral response characteristics are optimized for the 3-5 μ m range, which makes it ideal for imaging through aerospace coatings. Figure 8a provides a spectral transmission curve for two types of aerospace coatings involving an epoxy-based coating system and a polysulfide coating system. Figure 8b provides an additional set of transmission spectra for energy in the terahertz portion of the electromagnetic spectrum compared with the infrared spectrum results.

The results in Figure 8 indicate that for the same coating material, a high transmission (50% for the polyurethane and 18% for the polysulfide) could be obtained in the far-IR (THz) region compared to the relatively low transmission (8.5% for the polyurethane and 1.5% for the polysulfide) in the mid-IR region. The development and availability of terahertz detectors and sources is progressing in recent years, but is still several years off. Even with the <10% transmission levels, mid-infrared imaging has recently been shown to be capable of imaging through aerospace coatings. Figure 9 provides a set of images taken with the thermal camera system operating in a completely passive mode. The defect sites again appear as bright image features against a dark background. The defect sites correspond to a 1mm/side x 250 μ m deep triangle (Figure 9a), and two pitting corrosion samples (Figures 9b and 9c) that were \sim 200 μ m – 300 μ m in overall size, and 30 μ m - 50 μ m deep. The resolution, signal-to-noise, and image contrast levels were excellent when compared to the topographic features of the defect sites.

The only full-field measurement method studied directly in this present effort involved passive thermography. The possibility of utilizing imaging ultrasound, imaging eddy-current methods, and active thermography provide additional methods which show significant promise for the future. Wide-area coverage is perhaps the most important capability with regard to offering a potential replacement for visual inspection methods currently in use. Thermal imaging cameras offer the most immediate possibility for fast, simple, camera-based inspections for thru-coating inspection which mimics visual inspections. The limited transmission levels of 1-8%, however, will become an issue with problematic coatings and thicker coatings. Terahertz imaging systems are several years off, but offer another wide-area imaging method for thru-coating measurements as shown in Figure 8.
